Detector Data Communication System (DDCS) Loop Replacement Enabling Technology

JCT Paper

An Effective Fix for Failed Loops, Feeders and Ducts

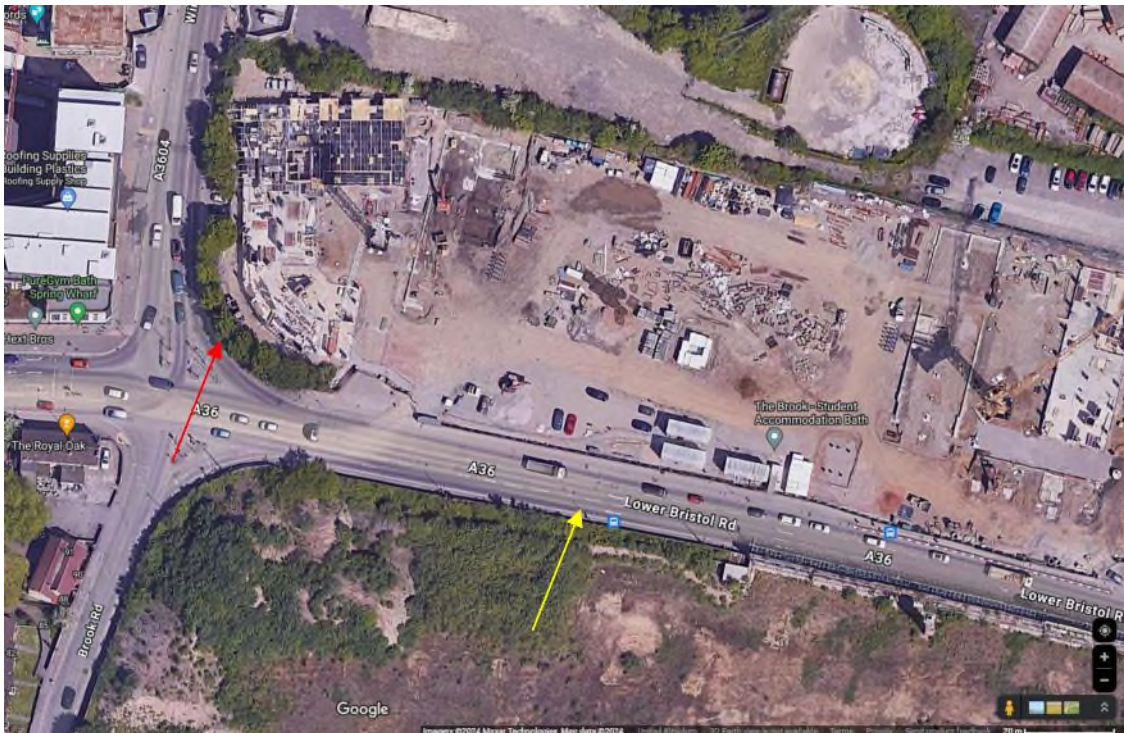
Figure 1 Satellite View of the Trial Site (Image ©googlemaps) with the SCOOT zone location arrowed yellow, controller location arrowed red.

Figure 2 shows the site and the location of the zones (yellow) and the controller (red).

A street lighting column was located a few meters to the west of the failed loops so this provided a suitable location for mounting a detector. BANES had selected an AGD 650 vision-based product that offered 2 distinct output zones, each of which could be configured for size, location, direction of travel of traffic and other characteristics, conveying a better level of functionality than the pre-existing loops offered.

The column is ~90 m from the controller cabinet, on the opposite side of the Lower Bristol Rd and is occluded from the cabinet by building structures.

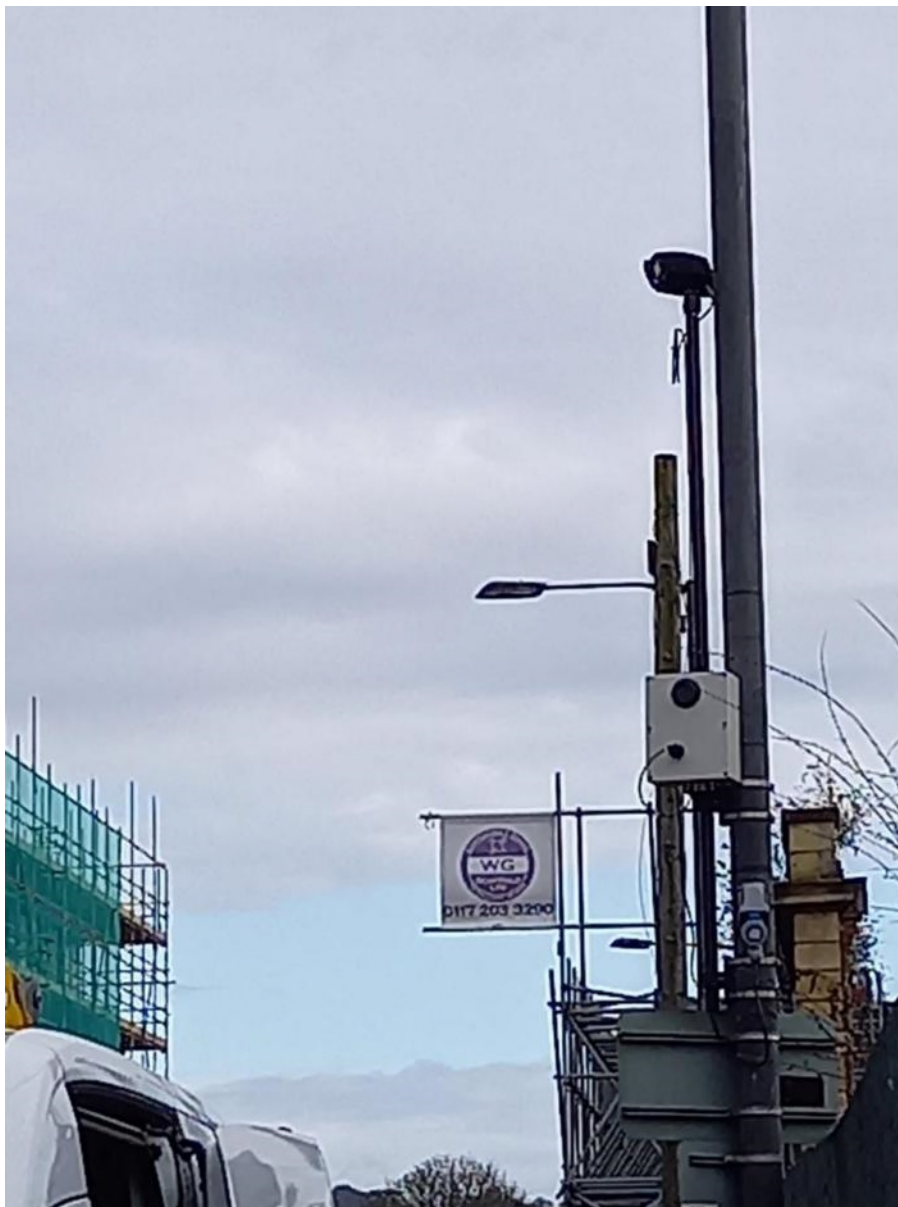
Figure 2 The installed Link and Detector

The detector and the pole mounted unit were located onto a daughter pole which was fitted offset from the lamp column.

The detector was oriented to give the right field of view and the wireless link unit turned to face the controller.

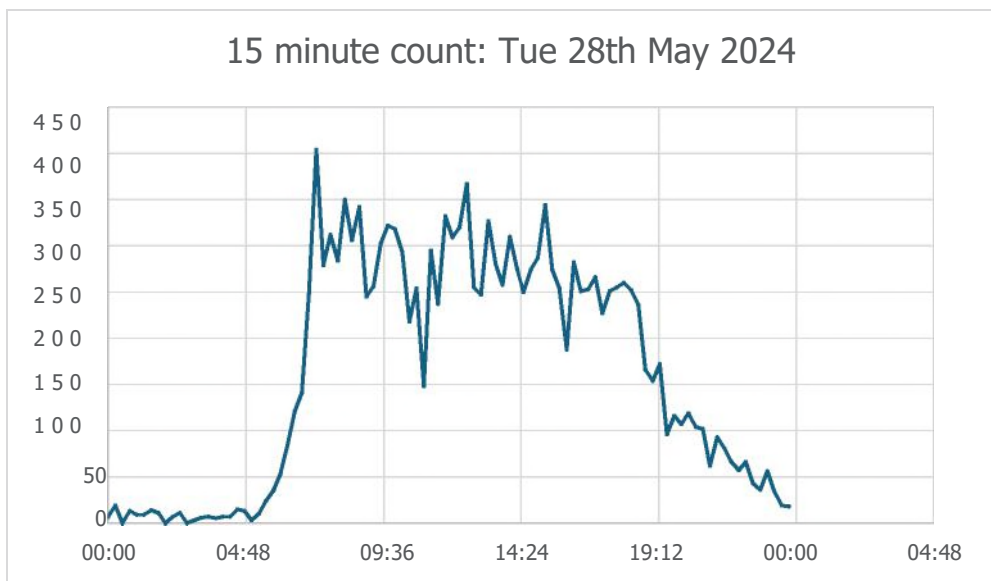
Figure 4 Typical 15 minute count data from N01241A (Lower Bristol Rd).

A typical period of data is shown in , and it can be seen that the data follows the expected daily flow cycle with no breaks or gaps.

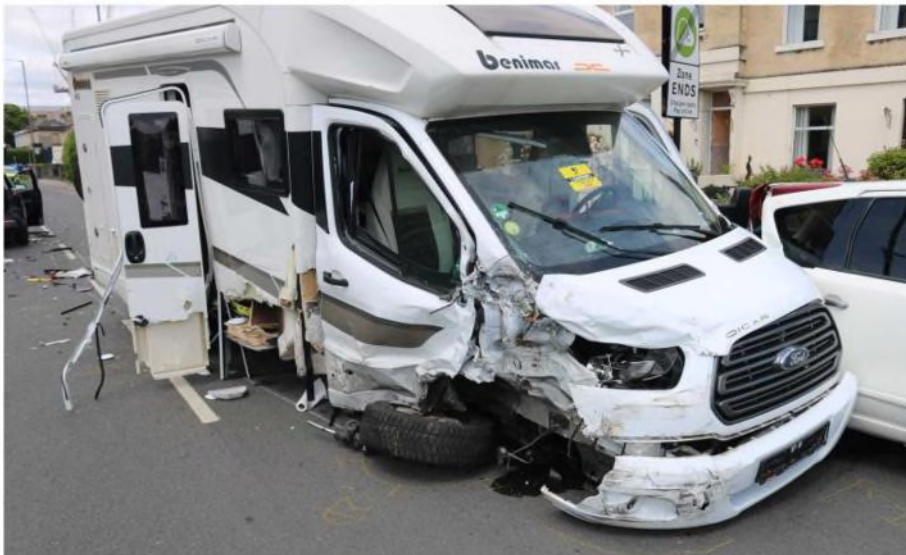
Figure 6 Evidence of an Incident 19th June a.m. Content © Bath Echo

The A36 Lower Bristol Road in Bath is expected to remain closed for most of the rest of the day following a serious multi-vehicle collision earlier this morning, Wednesday 19th June.

The flow profile of caused some concern until the information of was discovered.
