Petersfield Road Havant. Why and how did the Sparrow cross the road?

Mark Andrews, Intelligent Transport Systems (ITS) Group, Hampshire County Council

Introduction

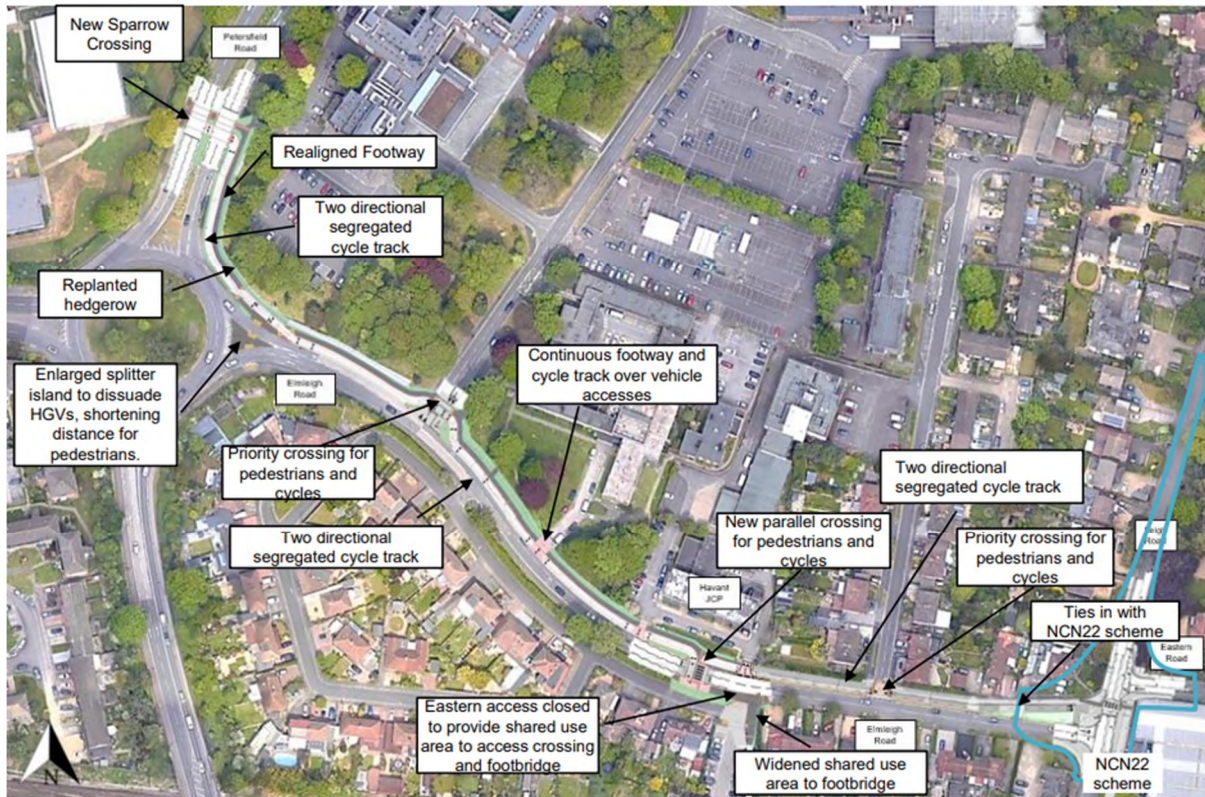
Figure 2 – Elmleigh Road scheme

In order to capitalise on the priority aspect of the scheme the new crossing on Elmleigh Road was identified to be a Tiger type crossing, similar to the already existing crossing at the Elmleigh Road junction with Leigh Road, and the crossing at Civic Centre Road to be a cycle priority crossing.

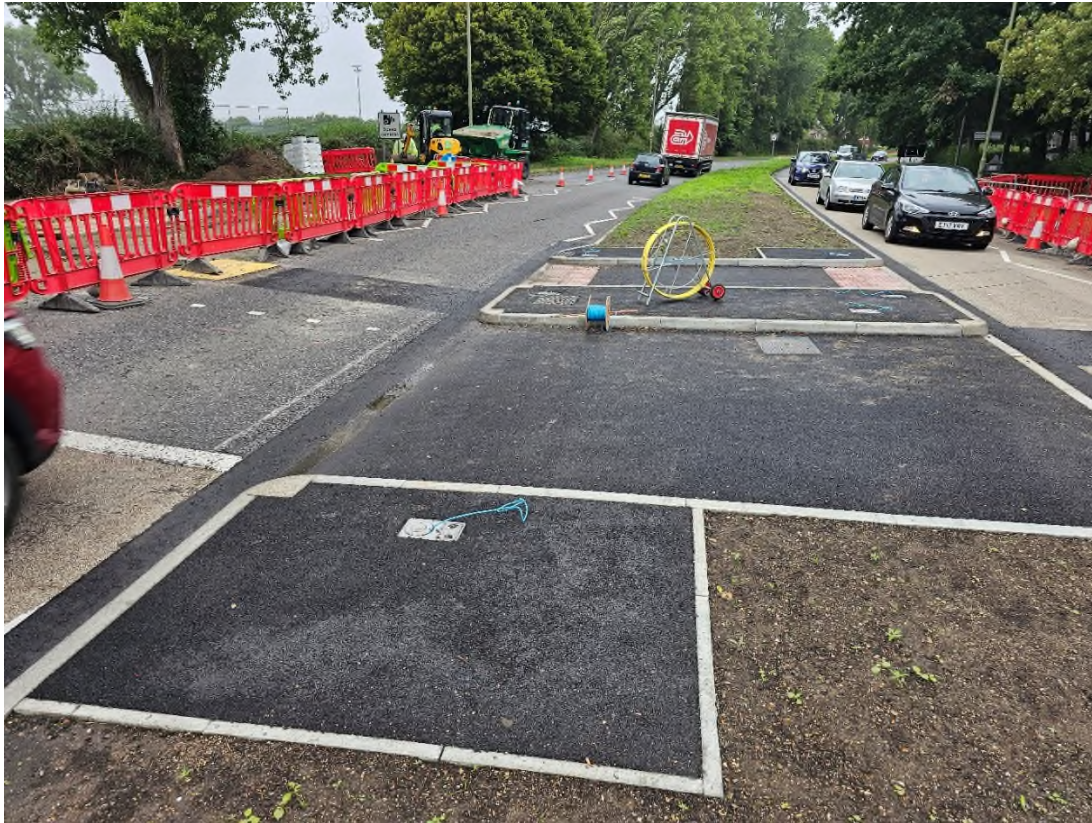
Figure 4 – Widened central island during construction

carriageway, it was not considered a practicable or safe option to allow the pedestrians to cross in a single phase. The overall crossing distance would have been 18 metres. Again, the intergreens for this would have been excessive. With the existing central reservation being only 3m in width it was recognised that this would have been inadequate to provide a dual in-line crossing for pedestrians. Localised widening of the central reservation was then developed to attain a 5 metre central separation for the dual in-line pedestrian phases. This layout allowed the pedestrian crossing to run parallel to the cycle crossing for the entire length of the facility whilst maintaining a separate pedestrian crossing over each carriageway

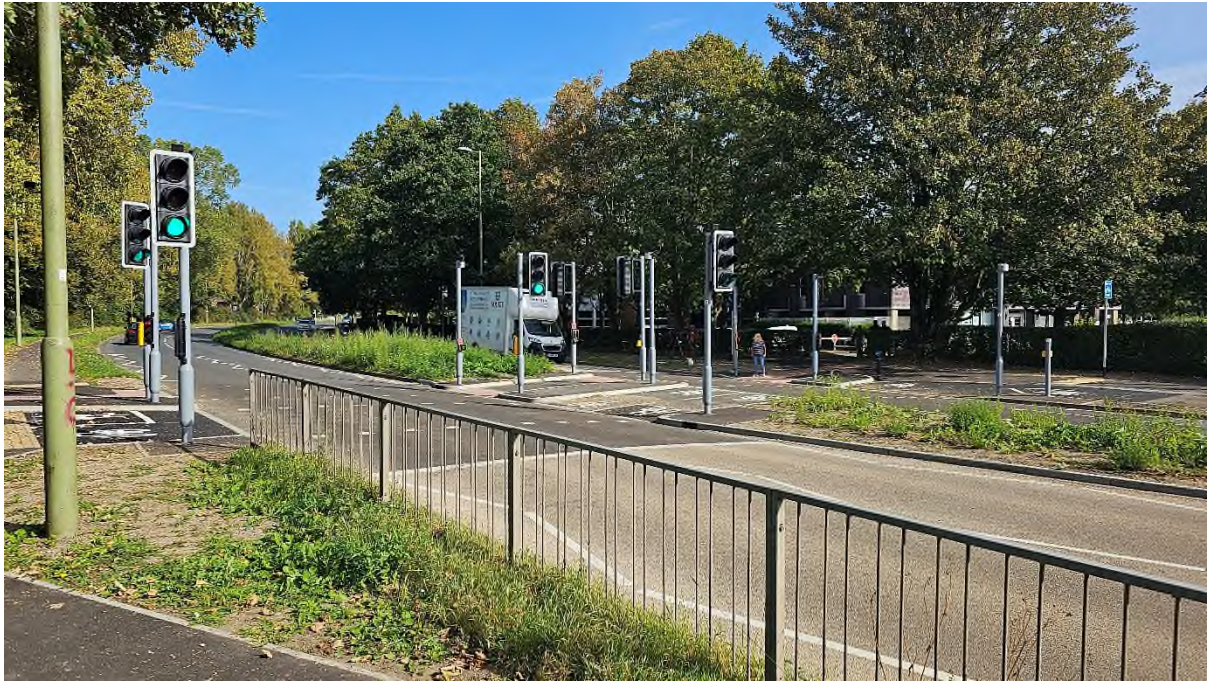
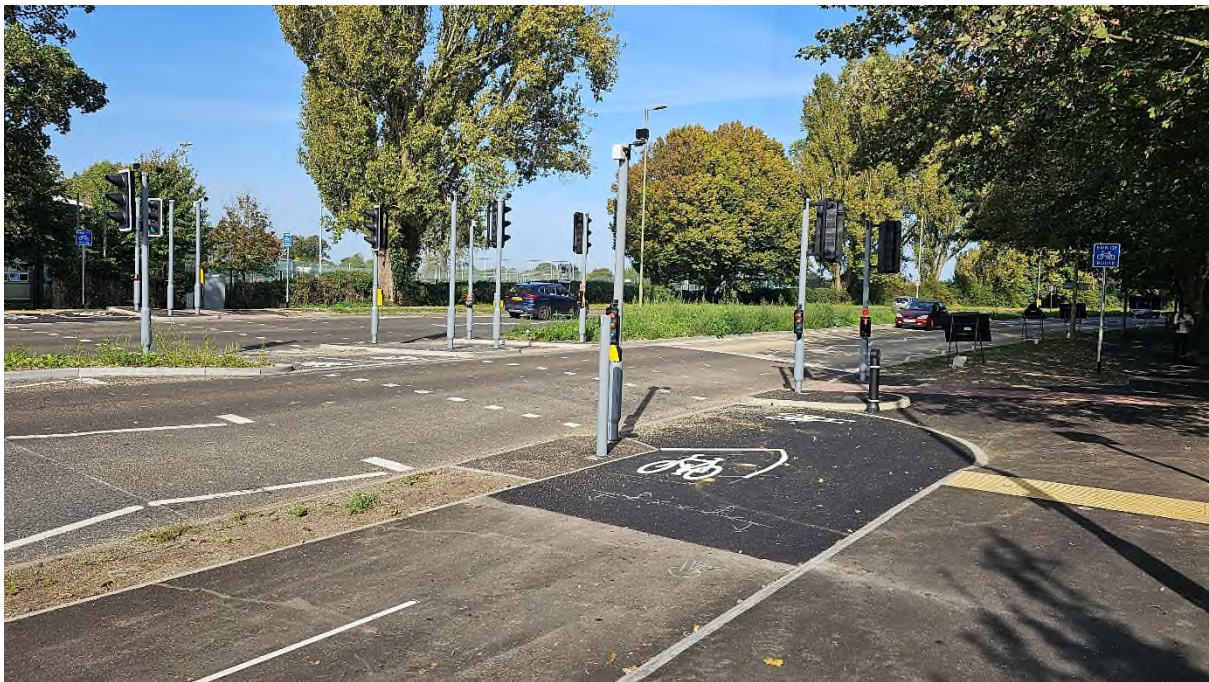
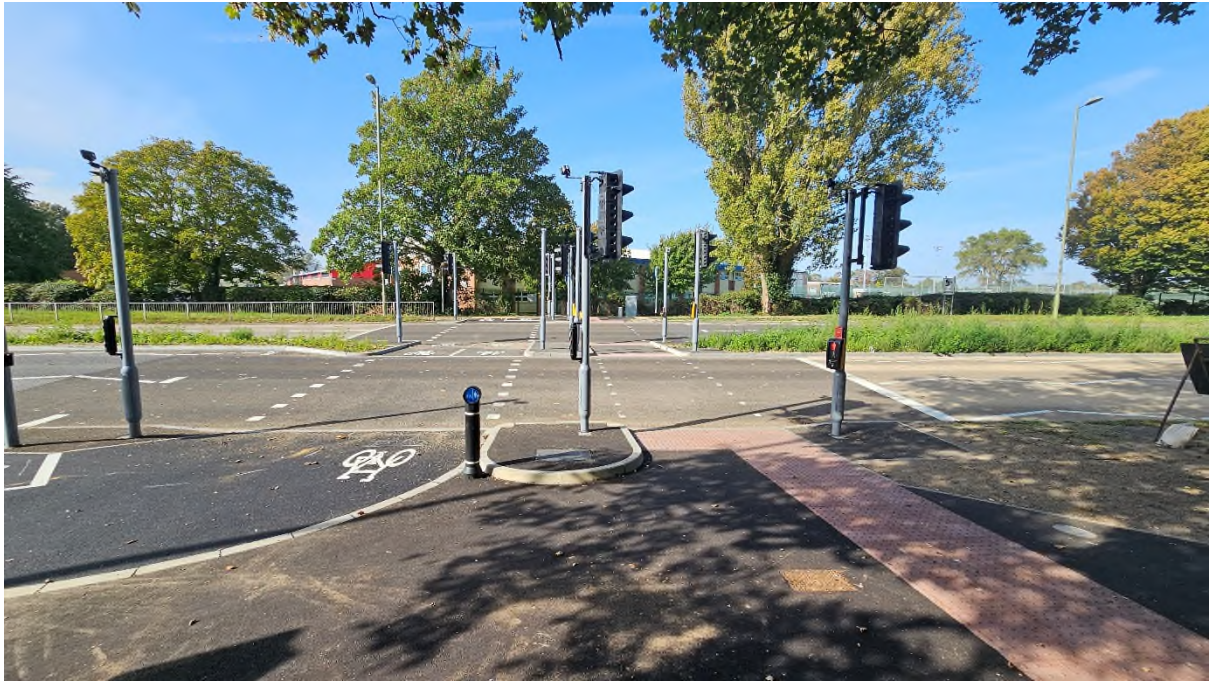
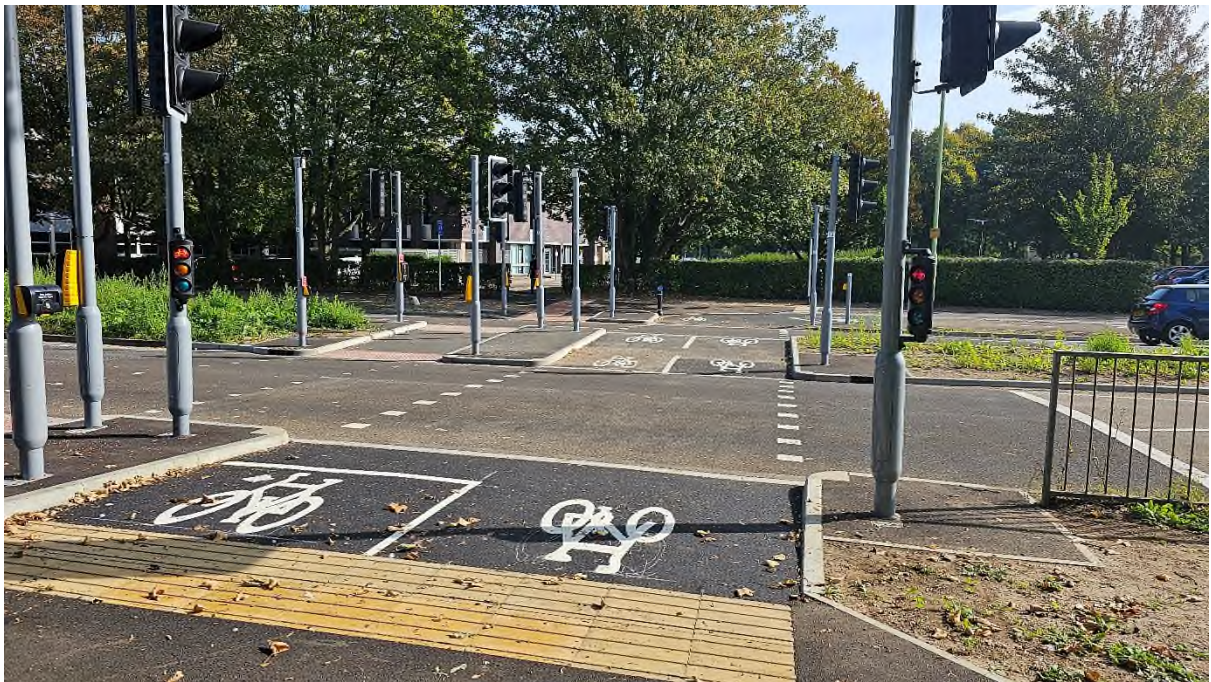
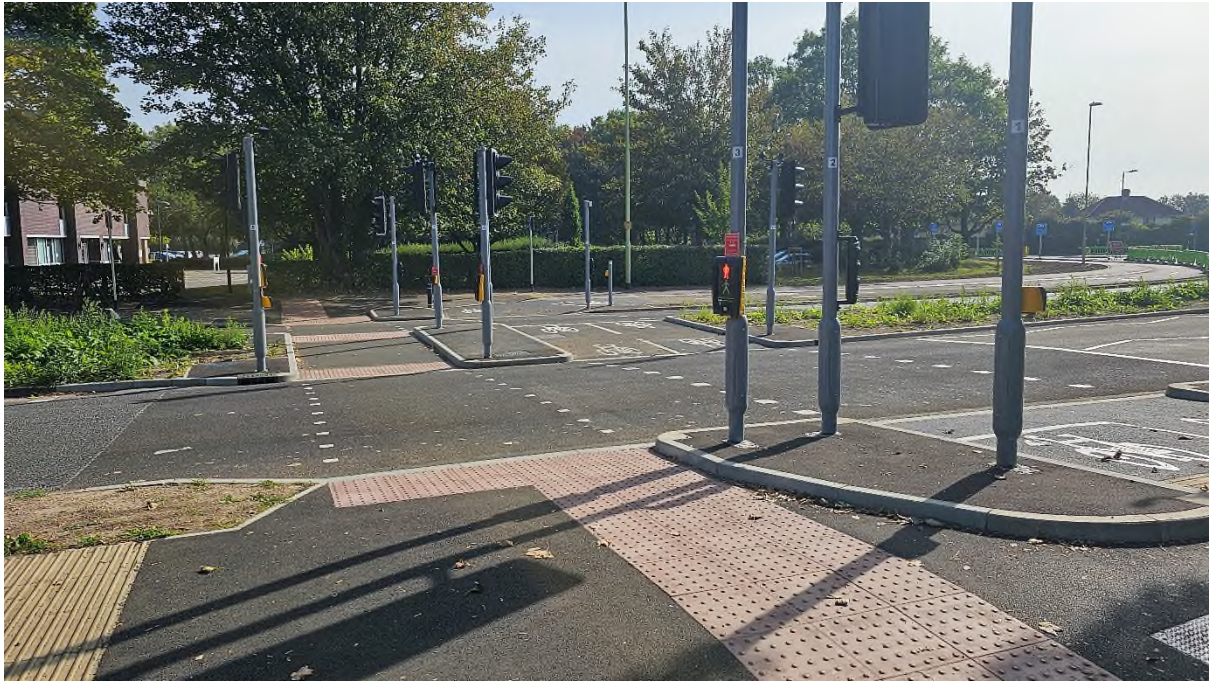
Figure 6 – Installed Crossing 1

Figure 7 – Installed Crossing 2

Figure 8 – Installed Crossing 3

Figure 9 - Installed Crossing 4

Figure 10 - Installed Crossing 5

A cyclist was used during the commissioning process to ensure the correct alignment of the low level cycle indicators and pushbutton units. The units were aligned to be visible on the approach to the crossing and whilst waiting at the crossing, with a STOP LINE being set 1m back from the kerb edge. The low level cycle indicators were installed in pairs on each side to provide a 'primary' and 'secondary' function. The secondary low level indicators also encouraged any waiting cyclists to look in the direction of on-coming traffic.
