Robert Whiteside, Kirklees Council
Andrew Caley Chetty, Starling Technologies

Challenging Pedestrian Crossings - Insights From Technology, Data and AI Optimisation Pt1

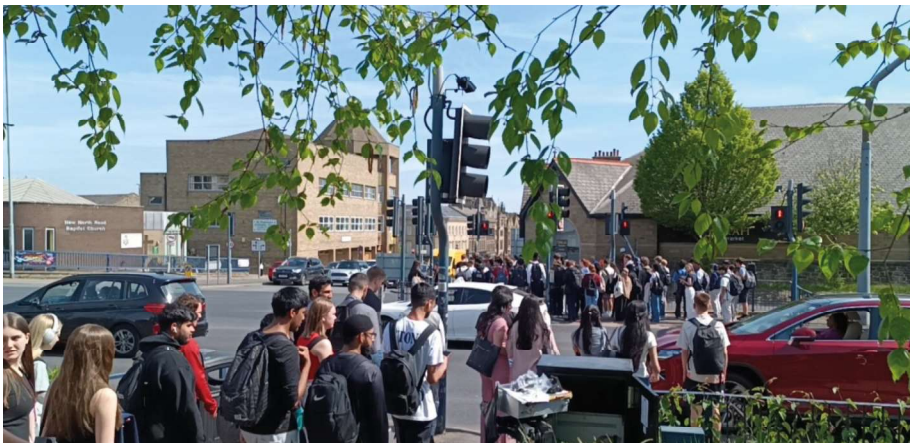
Figure 1 High Levels of Pedestrian Demand.

However, to make the situation more accessible Figure 1 and Figure 2 typify why there is a concern.

Figure 15 aligns with the experience of Figure 1 and Figure 2 but examination of Figure 16 shows that there is also a very high flow west in the mornings. It is reassuring that the Sunday flows for the two periods are very similar suggesting that the student movements are at least a substantial part of the excess flows seen in June over the flows in July. Also, the underlying flows (the blue trend) slopes oppositely to the red flows, suggesting that there may be a level of counter-propagating pedestrian friction both a.m. and p.m.

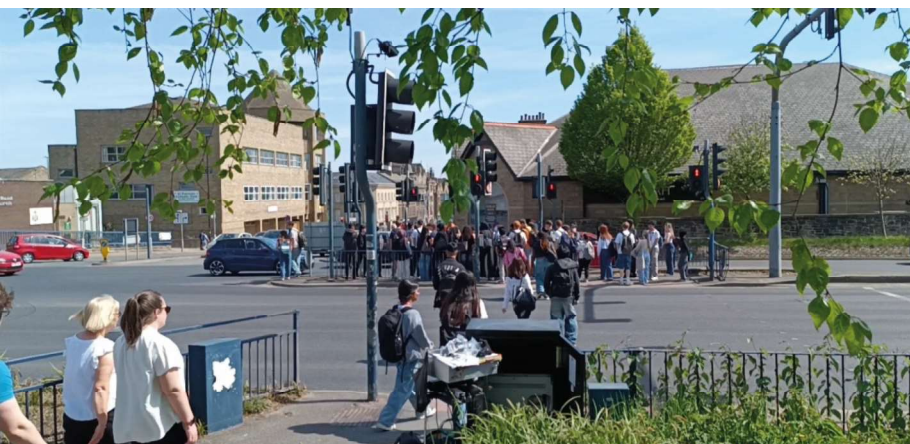
Figure 2 Pedestrian Non-Compliance.

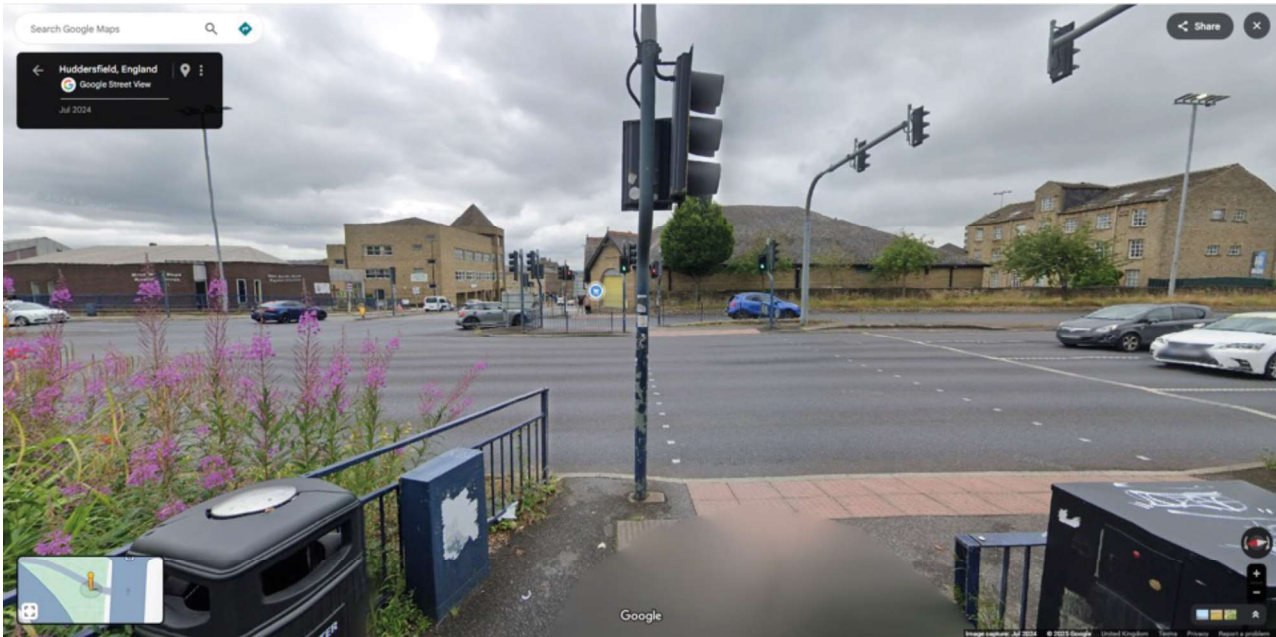
Figure 6 Street View of the crossing looking east towards the town centre.

The pedestrian route crosses the ring road which at this point has four lanes N bound and two lanes south bound. There is a slight downhill gradient towards the town centre.

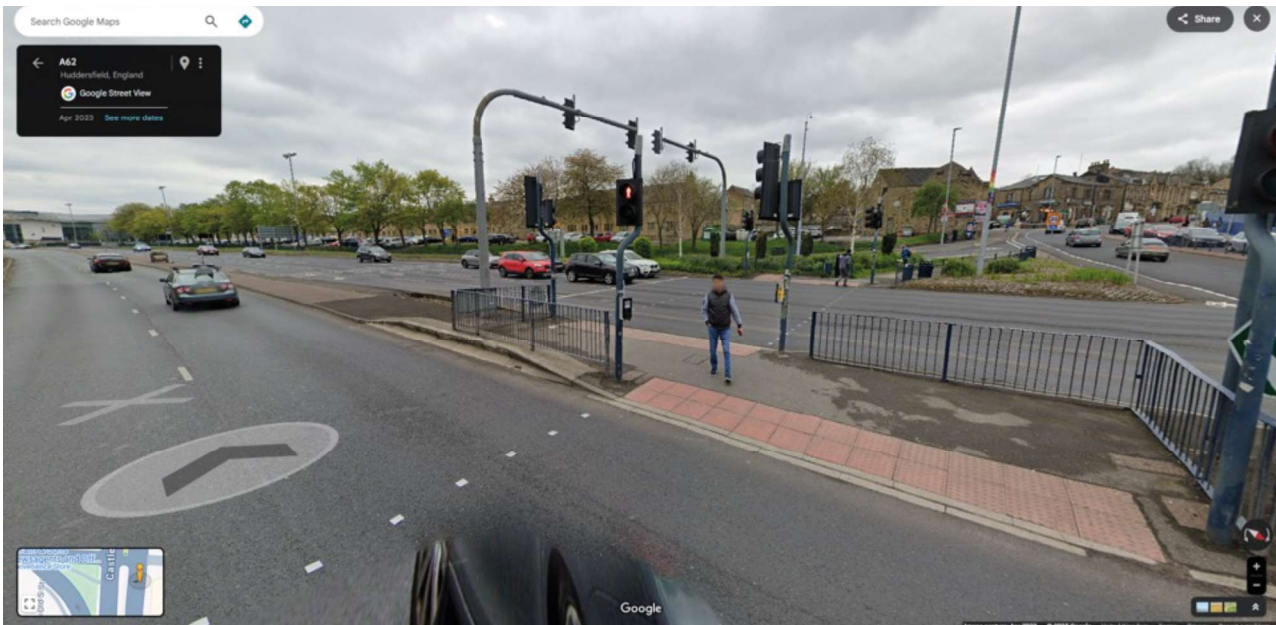
Figure 7 Street View of the refuge island at this crossing.

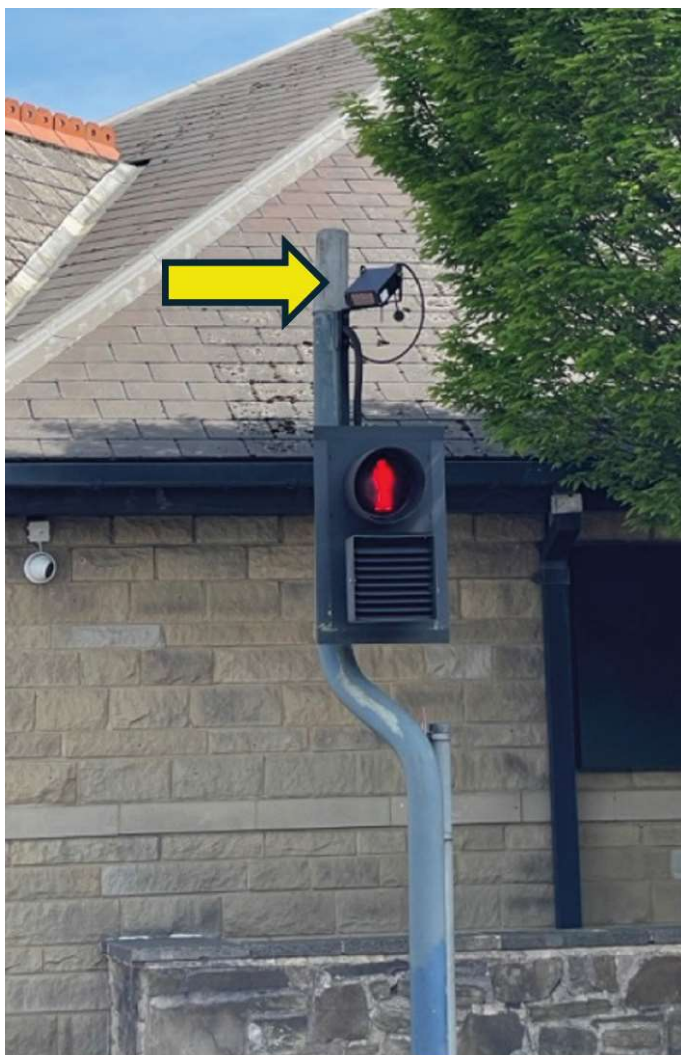
Figure 11 Starling Detector (Cam1) on the East Side of Phase J across the S Bound Ring Road.

Figure 10 shows the location and direction of coverage of the four Starling units that were set out on May 2025. Figure 11 to Figure 13 on the following pages show the installed detectors and the views that they provide of the crossing and refuge island.

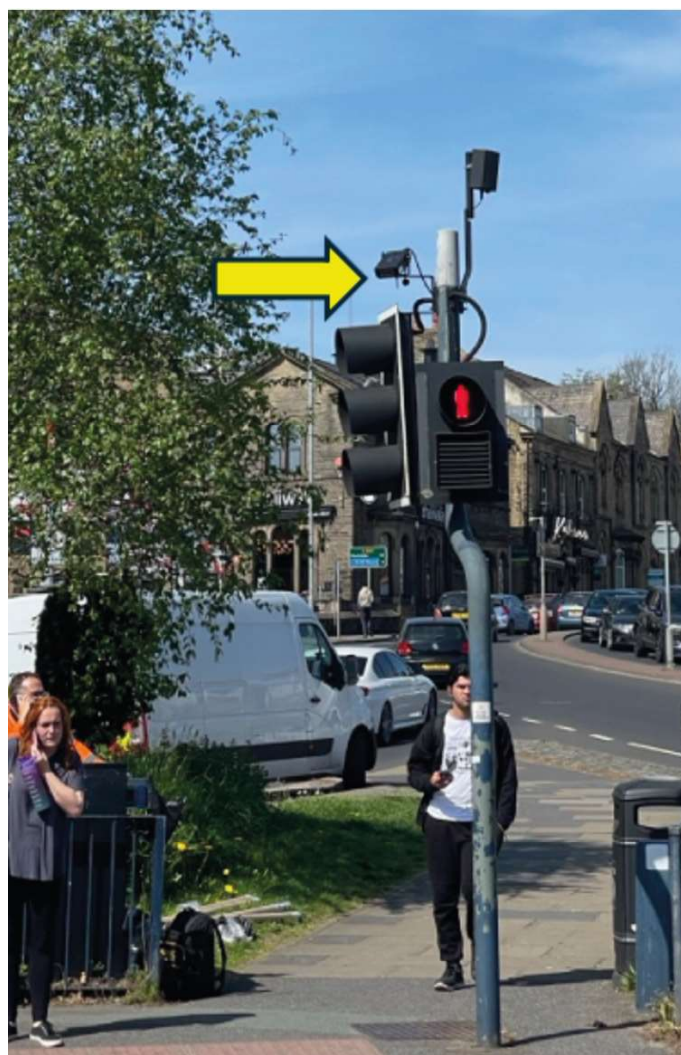
Figure 12 Starling Detector (Cam 4) on the West Side of Phase I across the N Bound Ring Road.

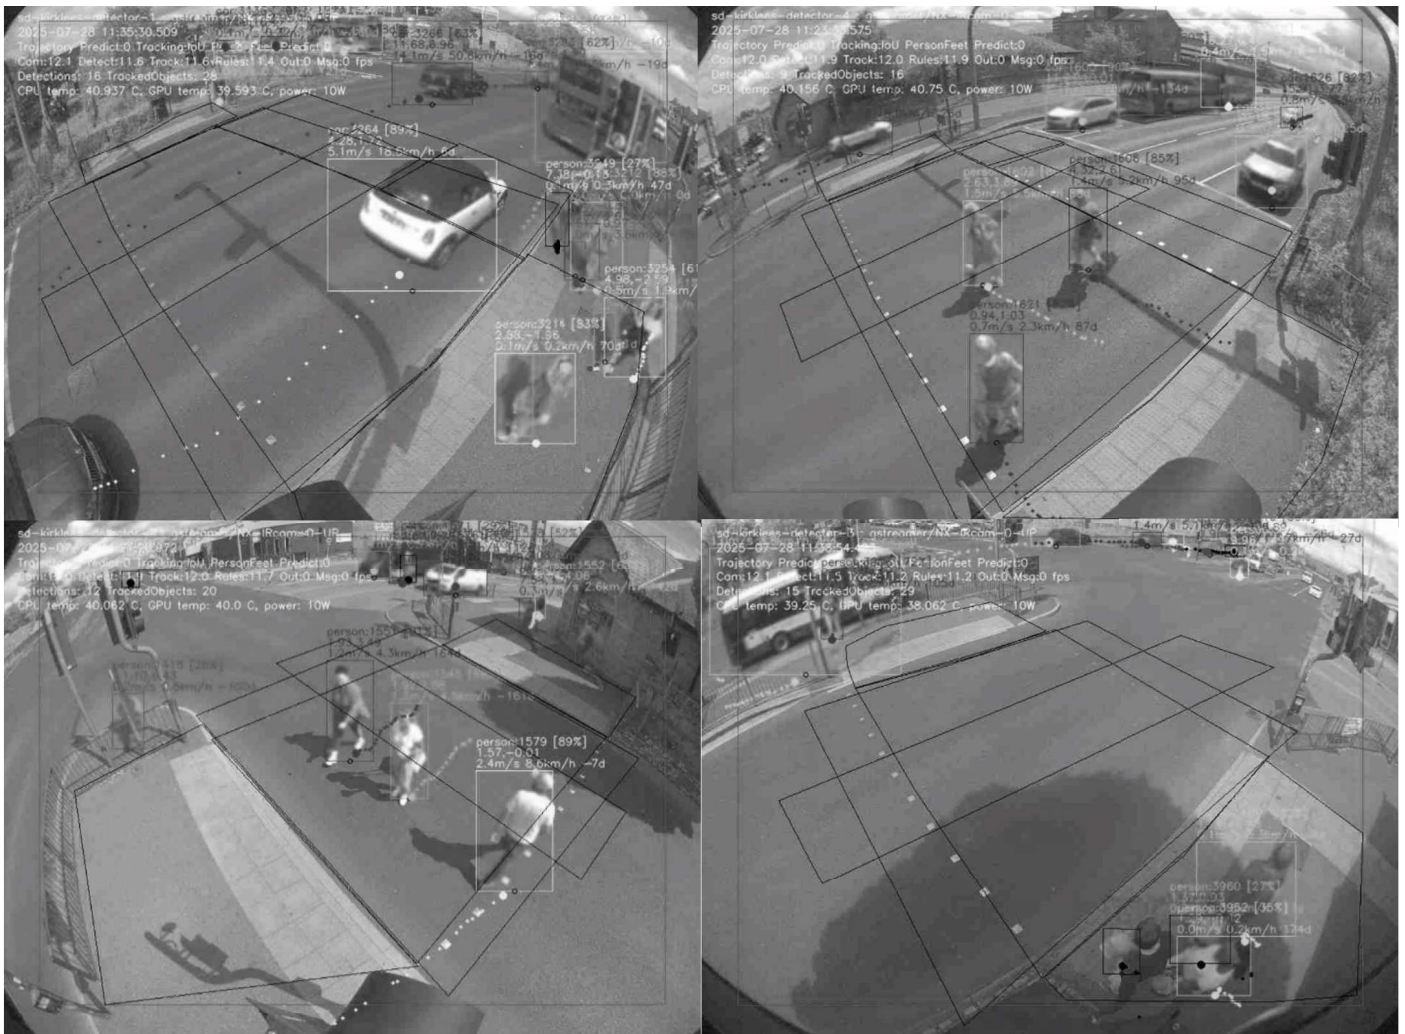
In Figure 13, the black boxes indicate zones of interest for the different scene parameters. Object and trajectory information are included in the images along with date and time stamps.

Figure 13 Starling Detector Views – Phase I Cam 1 top left, Cam 4 top right and Phase J Cam 2 bottom left Cam 3 bottom right. (Recoloured for easier interpretation).

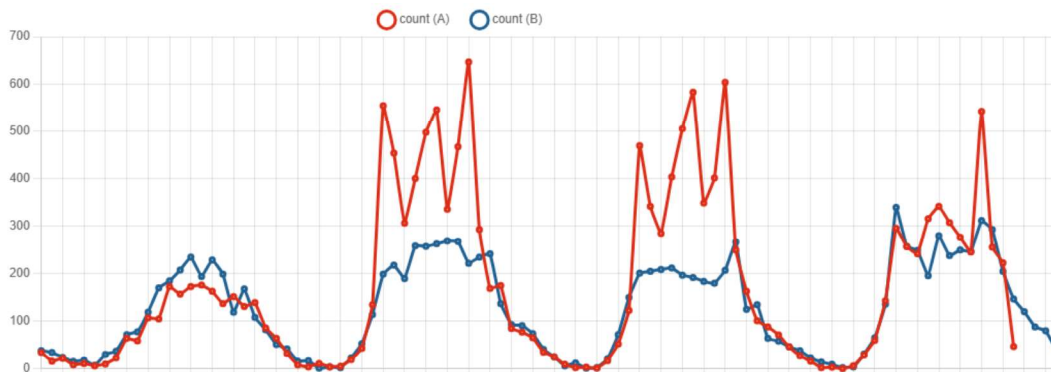
Figure 14 Bidirectional Pedestrian Flows (per hour) for Sun 1/6/25 - Wed 4/6/25 (red) and Sun 13/7/25 - Wed 16/7/25 (blue).

Figure 14 compares the start of a term-time week, to a corresponding period only 6 weeks later. Sundays are included to compare non-school day flows.

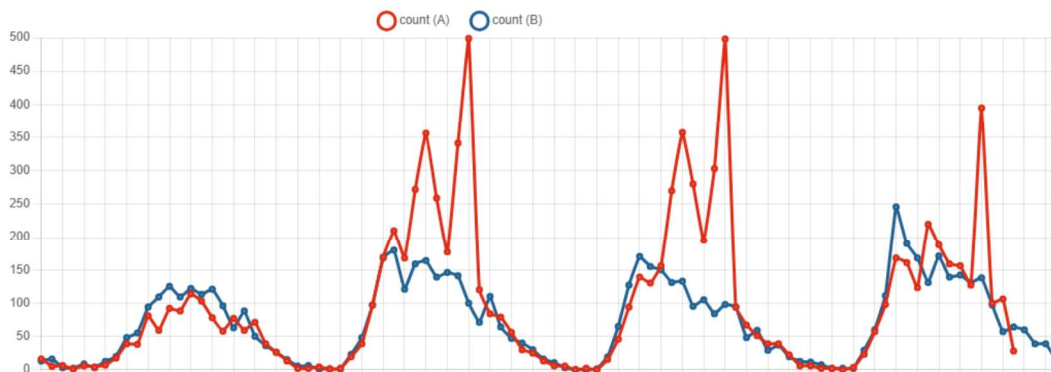
Figure 15 East bound (town-wards) Pedestrian Flows (per hour) for Sun 1/6/25 - Wed 4/6/25 (red) and Sun 13/7/25 - Wed 16/7/25 (blue).

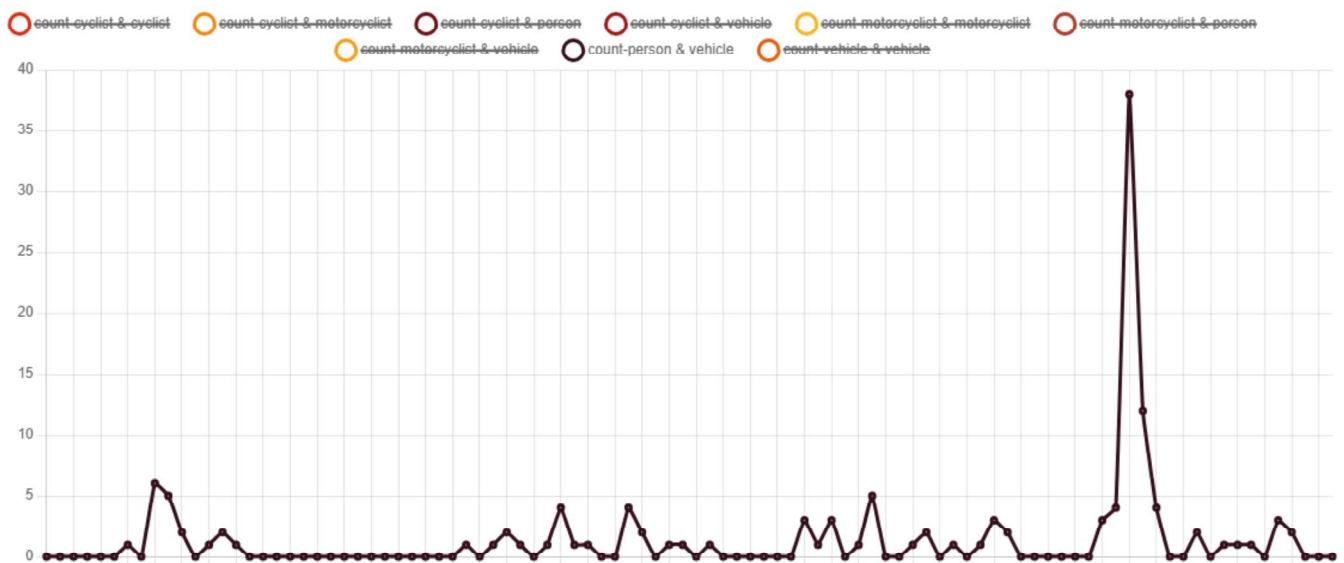
Figure 17 shows one bad situation occurring on the Wednesday morning with 38 near misses recorded on the four lane N bound part of the crossing.

Figure 17 Pedestrian to Vehicle Near Misses Phase I (four lanes) Sun 13/7/25 – Wed 16/7/25.

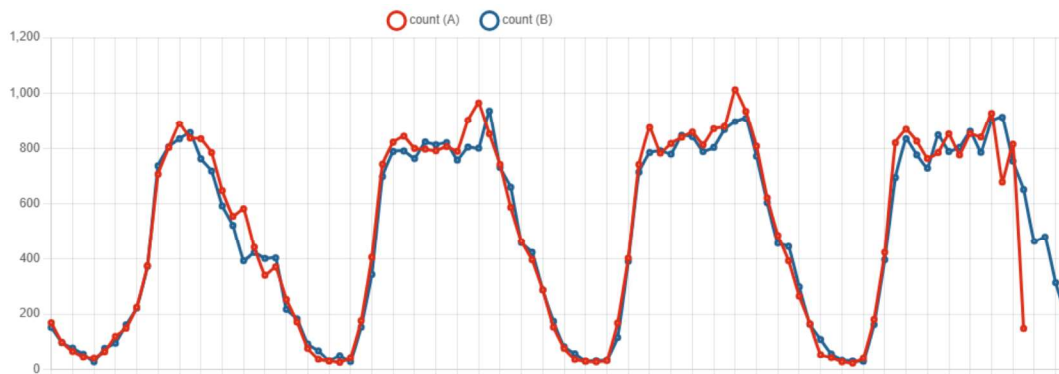
Figure 19 suggests that the ring road vehicle flows are relatively stable between term times and college holidays, so dropping off SCOOT may also bring problems, however it would be wrong to infer this only from data from this site.

Figure 19 A62 Castlegate N bound flows Sun 1/6/25 – Wed 4/6/25 (Red) and Sun 13/7/25 – Wed 16/7/25 (blue).
